Lucien Laiarinandrasana, Thilo F. Morgeneyer, Henry Proudhon, Lukas Helfen, Jacques Besson. Local approach of fracture on semi-crystalline polymers : contribution of X-ray laminography technique. 13th international conference on fracture, Jun 2013, Beijing, China. 11 p. hal-00853439

# Local approach of fracture on semi-crystalline polymers: contribution of X-ray laminography technique

**Abstract** Damage mechanisms in a PolyAmide 6 semi-crystalline polymer were characterized by using Synchrotron Radiation Laminography technique on CT like specimen. Damage appeared as multiple penny shaped crazes. The maximum damage occurred at mid-thickness and located at a small distance from the notch root. An attempt was made to apply local approach of fracture concept thanks to finite element analysis using damage-based constitutive model. FE simulation successfully captured the aforementioned micro-mechanisms of crack initiation, by void coalescence. Further work is carried out to determine the crack dimension corresponding to the maximum net stress: the criterion being used for the global approach of fracture.

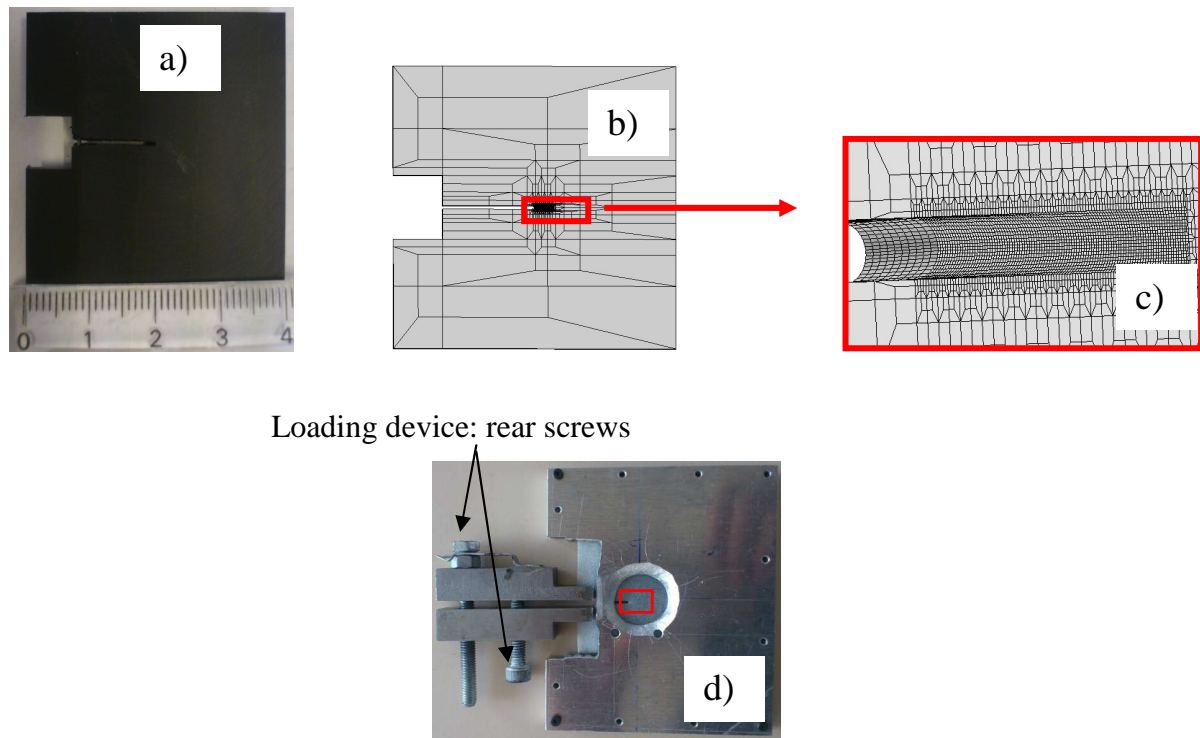
radius  $\rho = 250\mu\text{m}$ , half height  $H/2 = 20\text{mm}$ . For the following FEA (section 3), figs.1b-c respectively illustrate the CT specimen overall meshing and refined meshes ( $25\mu\text{m}$ ) in the vicinity of the crack tip.

Figure 1. CT specimen geometry with the experimental setup: a) CT specimen sketch; b) Overall view of the sample meshing; c) Fine meshing near the notch root (mesh size  $25\mu\text{m}$ ); d) Experimental setup.

The experimental setup is presented in fig.1d. The CT specimen was inserted between two aluminum plates to avoid buckling in the compressive part of the remaining ligament. The opening displacement is applied thanks to the turns of both rear screws. A circular window was designed within the anti-buckling aluminum system allowing for inspection of the region near the notch root, at the macroscopic scale (pictures), as well as at the microscopic scale (laminography scans).

carried out. A procedure of “kill/remove element” was applied when a critical porosity value was reached within this element. The following analyses focus on the refined meshes (fig. 1c) in the vicinity of the notch root. Constant mesh size of  $25\mu\text{m}$  was set for  $2.5\text{mm}$  along the ligament.

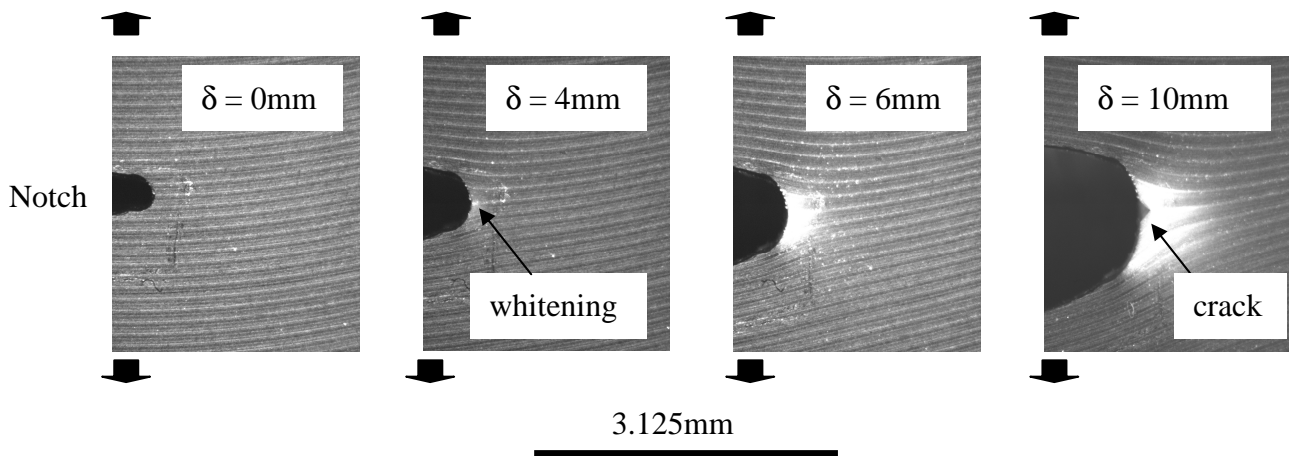
Figure 2. Evolution of the geometry observed at the external face of the CT specimen. Black arrows indicate the loading direction.

Stepwise loading was applied between laminography observations. Fig.2 shows a series of pictures made at the side view of the specimen before the laminography scans. The corresponding applied displacement  $\delta$  is indicated in each viewgraph, starting from the initial material without any deformation, up to  $\delta = 10$  mm. For this latter, a crack is visible at the external surface of the sample. For  $\delta = 4$ mm, a localized whitening at the notch root is observed. Being the first event appearing at the surface, it was considered that this corresponded to an internal crack initiation. For  $\delta = 6$ mm, whitening is spreading out, surrounding the notch root. It should be mentioned that no scan was done between  $\delta = 6$ mm and 10mm. Moreover, the present experimental setup was not equipped with a load cell. The load level was therefore estimated by using FEA with a dedicated constitutive model.

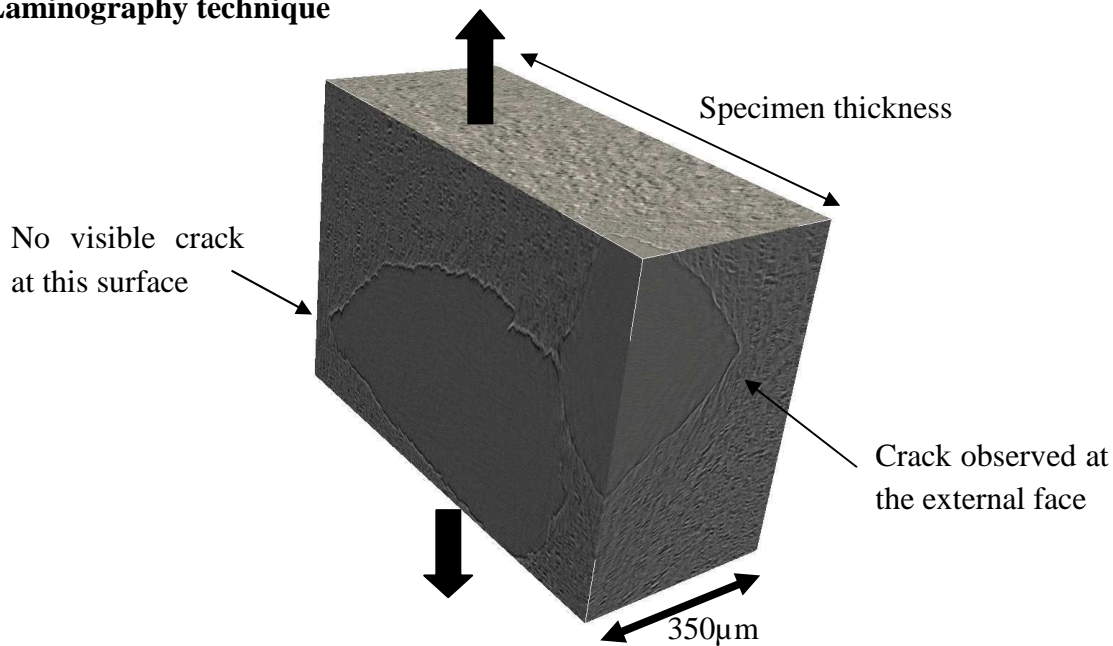
Figure 3. Volume corresponding to  $\delta = 10$ mm: two cracks through the thickness

Synchrotron Radiation Laminography (SRL) technique is detailed elsewhere [3]. It has already been applied on both metallic and laminate composite materials. To the authors' best knowledge, it is the first time that this technique is utilized for semi-crystalline polymer investigations. To this end, for each value of the applied opening displacement  $\delta$  the whole experimental setup (fig.1c) was mounted on adapted sample support of the laminography device at the ID19 beamline of the European Synchrotron Radiation Facility (ESRF) in Grenoble (France). The scanned volume was about  $1 \text{ mm}^3$ , with a voxel size of  $0.7 \mu\text{m}$ . Fig.3 shows a trough thickness microstructure around the crack tip in 3D. Apart from multiple crazes observed within the whole volume, two large cracks were evidenced. One of them appeared at the surface (fig.2,  $\delta = 10$  mm) whereas the opposite face did not show any crack. Attention is now paid on the scans corresponding to  $\delta = 4$ mm and  $\delta = 6$ mm to observe the microstructure, especially at mid-thickness.

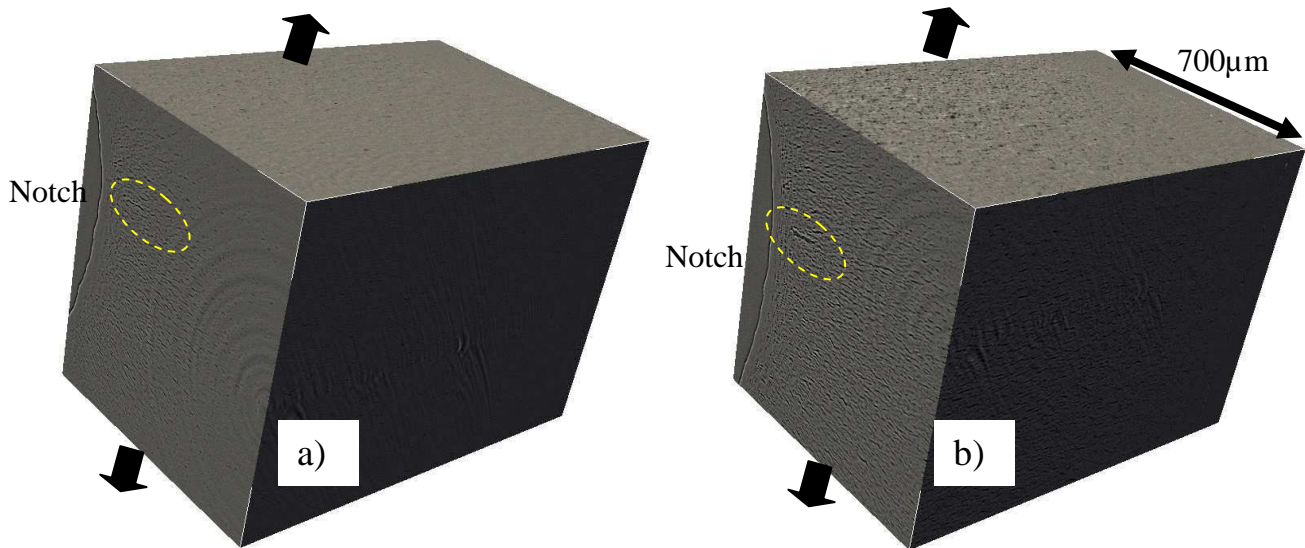
Fig.4 illustrates such views in 3D where the plane at mid-thickness is shown in forefront. Multiple penny shaped crazes [2, 4] were observed around the notch root. These features could be linked to the whitening observed at the macroscopic scale.

Figure 4. Observations at mid-thickness plane: a)  $\delta = 4\text{mm}$ ; b)  $\delta = 6\text{mm}$

A significant damage, surrounded by the dashed lines was evidenced at mid-thickness, located at a small distance ( $\sim 100\mu\text{m}$ ) from the initial notch root.

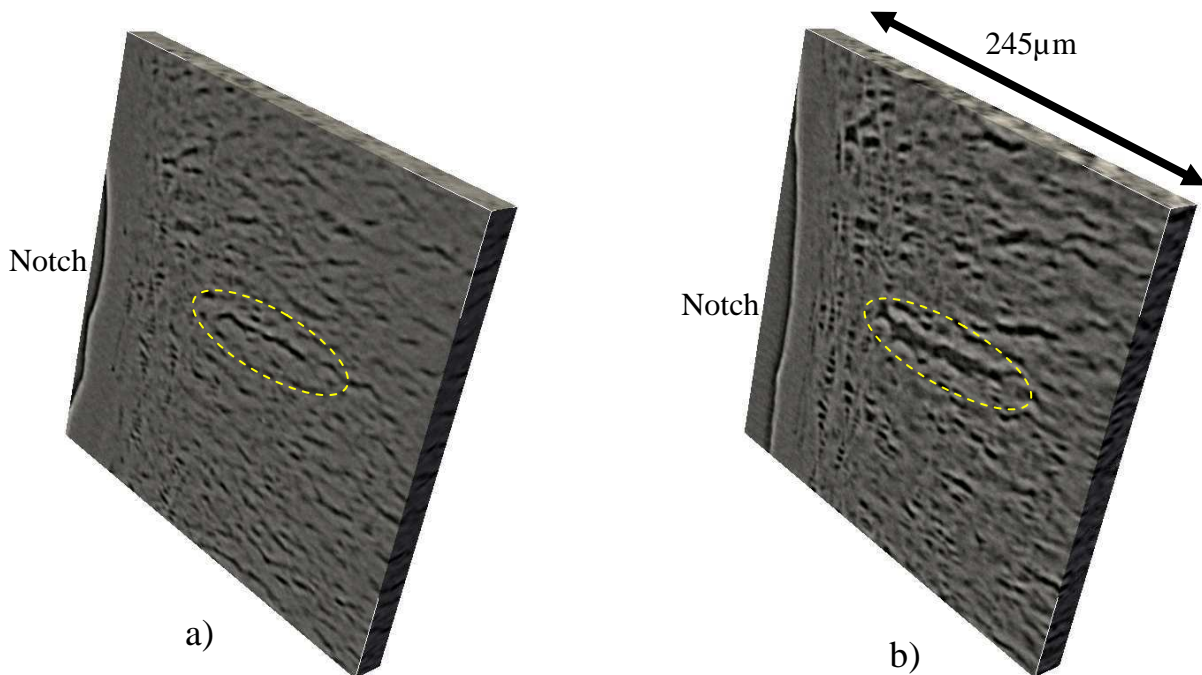
Figure 5. Maximum damage at mid-thickness surrounded by dashed lines: a)  $\delta = 4\text{mm}$ ; b)  $\delta = 6\text{mm}$

Fig.5 details the morphology and the size of this damage. To this end, a  $19\mu\text{m}$  thick slice of PA6 scan was extracted and analyzed for both  $\delta$  values. It was observed that the damage consisted of crazes (presence of fibrils within the voids) aligned (coalesced) following the crack remaining ligament plane. This damage increased in height from  $\delta = 4\text{mm}$  to  $6\text{mm}$ . Its average values of the characteristic dimensions were summarized in Table 1.

$\delta = 4\text{mm}$	$\delta = 6\text{mm}$
Length	$60\mu\text{m}$	$90\mu\text{m}$
Height	$5\mu\text{m}$	$10\mu\text{m}$
Width	$20\mu\text{m}$	$30\mu\text{m}$

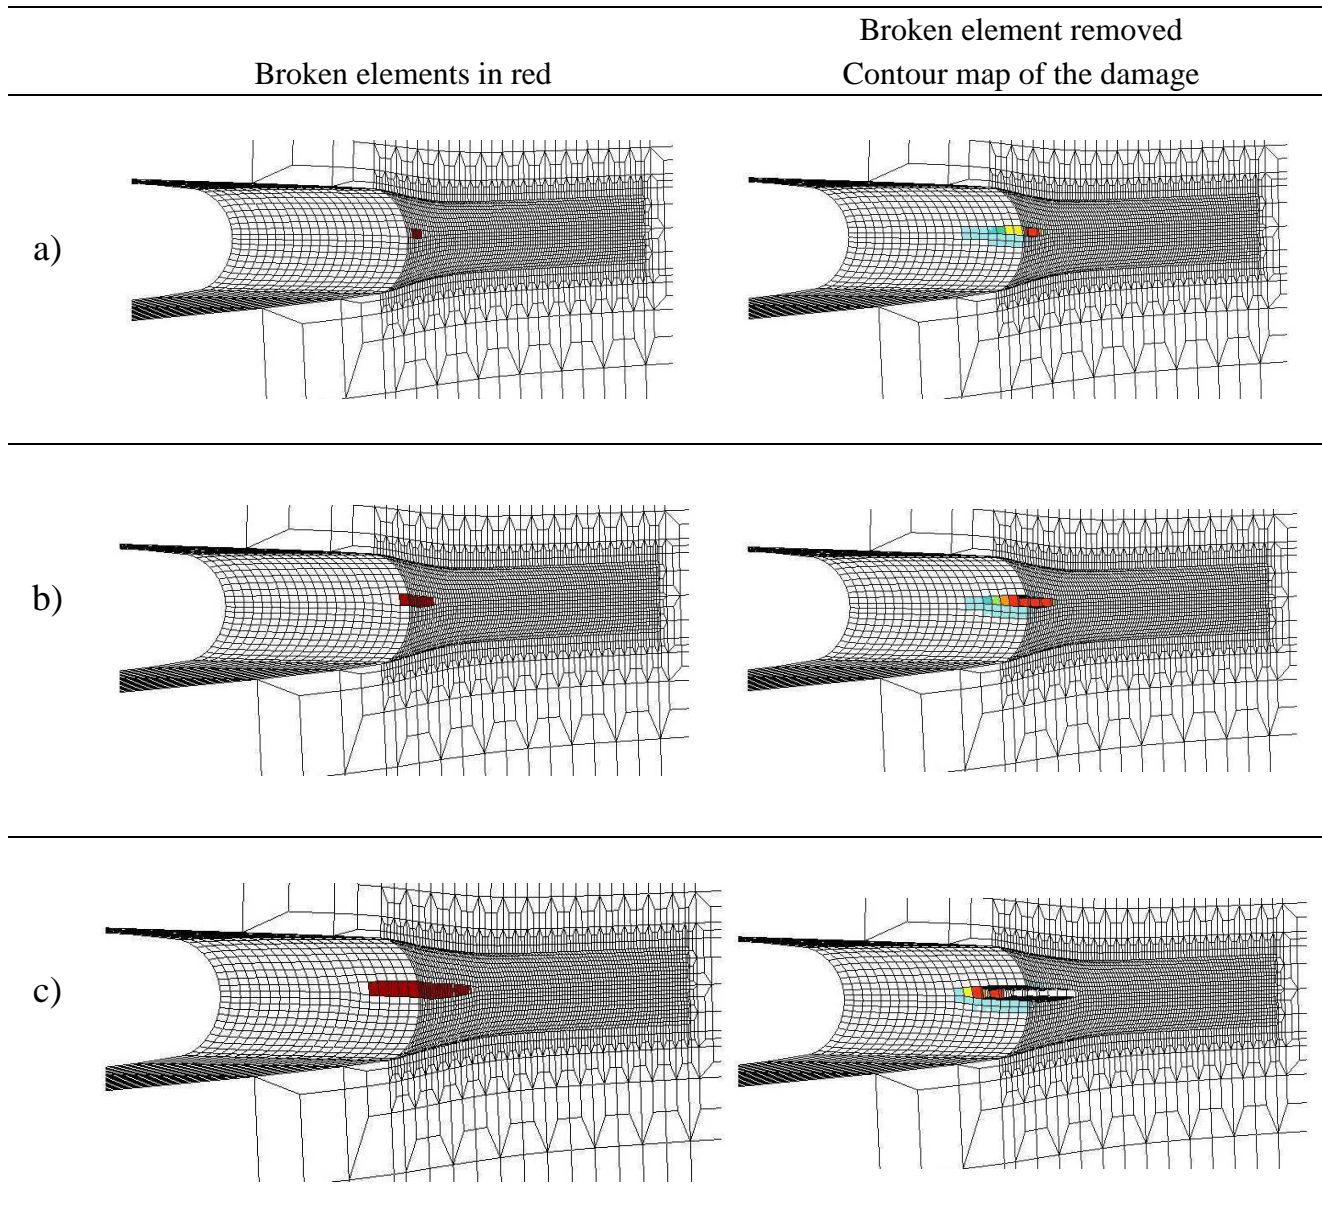
Figure 6. FE simulations of the crack initiation by using damage based constitutive model.

Fig.6 summarizes the evolution of damage (broken element) during the increasing load. The forefront face corresponds to the plane at mid-thickness. The first column of deformed meshes shows the broken elements in red. The second column illustrates the contour map of the void volume fraction over the deformed mesh where the broken elements were removed.

Fig.6a shows that four elements simultaneously broke for the first time (length  $\sim 100\mu\text{m}$ ; width  $\sim 25\mu\text{m}$ ). They appeared at mid-thickness and located at 3 elements away from the notch root (distance  $\sim 75\mu\text{m}$ ). These characteristic values correspond to those of  $\delta = 6\text{mm}$ . Fig.6b indicates that broken elements propagate into two opposite directions: ahead of and back to the notch root. The width seems to remain constant (one element size). Fig.6c evidences that the broken elements propagates through the thickness as well, but did not reach the external surface. These latter steps were not observed with SRL technique since no scan was done between  $\delta = 6\text{mm}$  and  $\delta = 10\text{mm}$  when the crack appeared at the external face. However, although fine tuning of damage parameters is still ongoing, these figures demonstrate that the FE analysis with the damage based model was able to reproduce the micro-mechanisms of crack initiation. At present time, computation is still running to obtain the configuration where the crack reaches the external surface.

Contour maps presented in fig.6 correspond to the last loading steps of the numerical simulations ( $\delta \geq 4\text{mm}$ ). The first results shown at this stage indicate that although a non linearity appears in the last part of the plot (fig.7), the net stress is still increasing. The maximum net stress is not yet reached. Final results will be shown later.

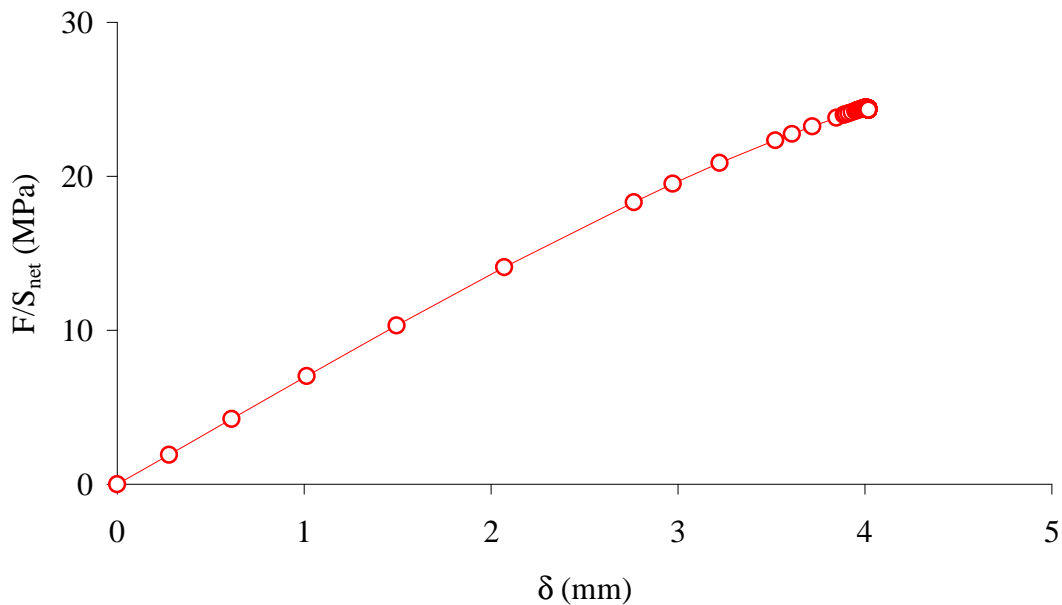
Next investigation consists of using FE modelling to estimate the load evolution during the crack propagation. The aim is to determine the crack size allowing the crack initiation criterion at the macroscopic scale to be reached (maximum load). To this end, in fig.7 the load divided by the net section of the remaining ligament is plotted as a function of the applied opening displacement.

Figure 7. Net stress as a function of the opening displacement by FE analysis
